## **Drag beam failures**

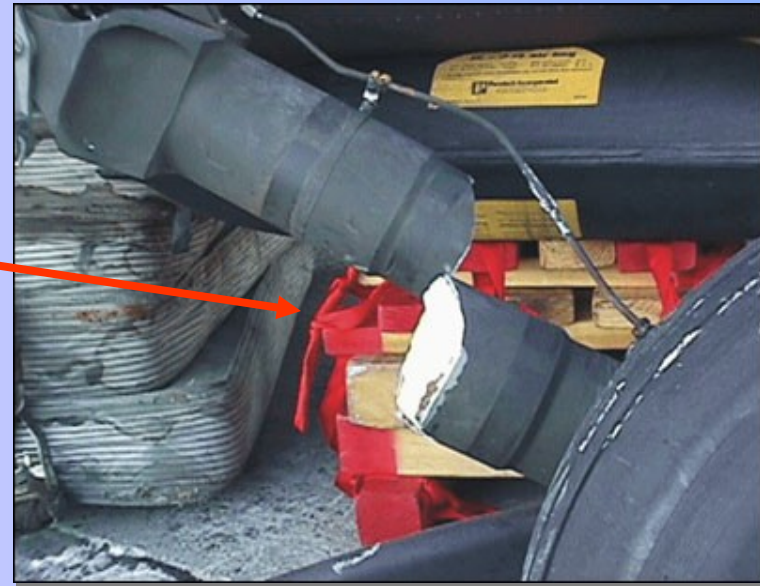
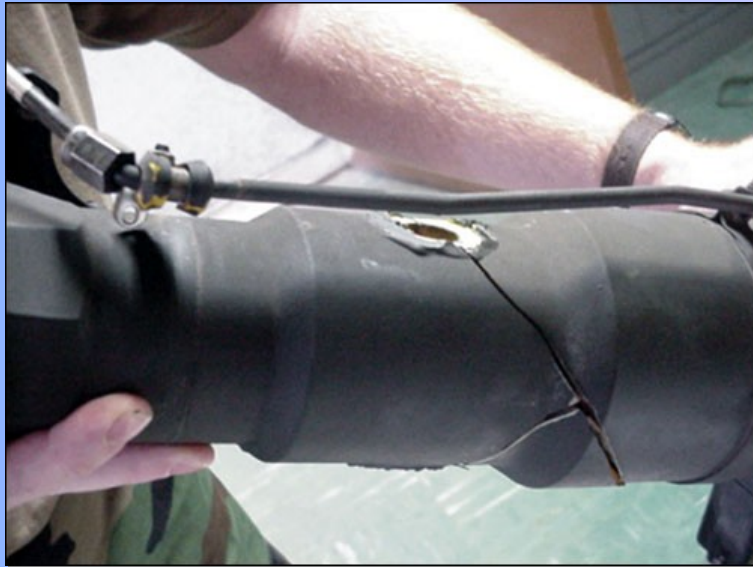
**Stress corrosion crack at  
jack-pad / tiedown pin hole  
(pin missing)**

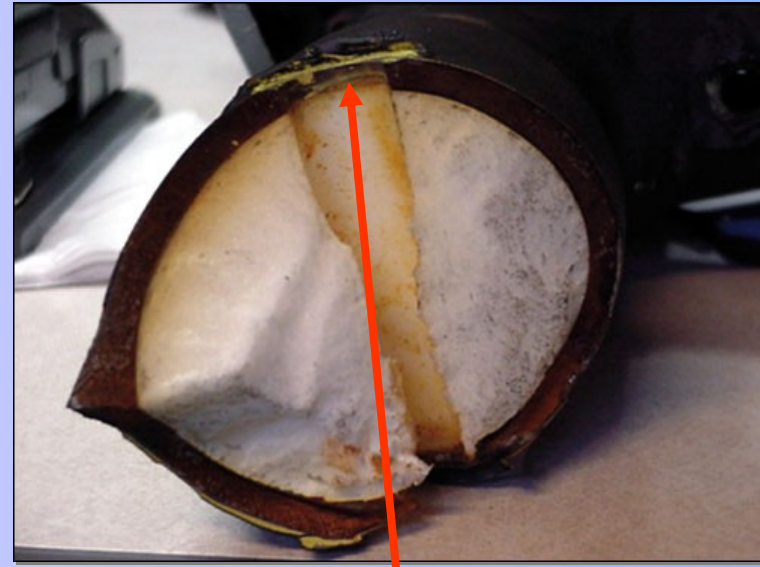
**Cross section of cracked drag beam  
showing stress corrosion at point  
where pin is located.**
